SUAT BEY

IMO9070515

Type: General cargo

[MV Suat Bey](#) arrived in Catania (Italy) on 09nov2013, with a standard risk profile.

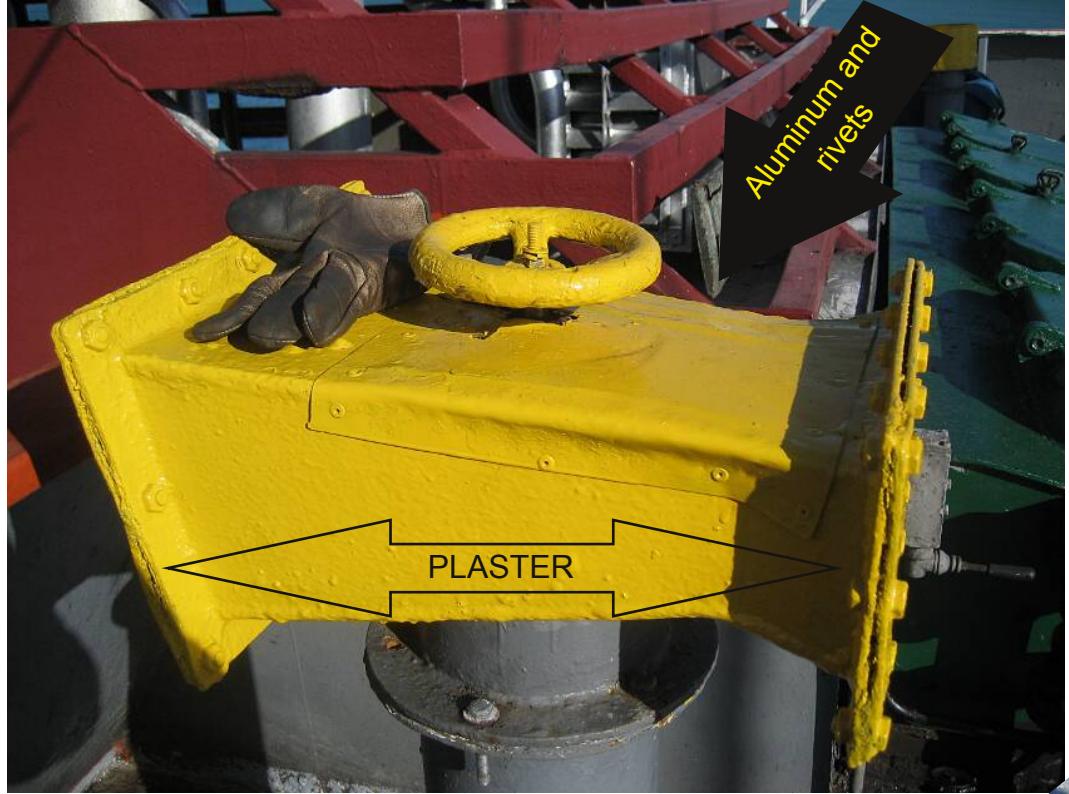
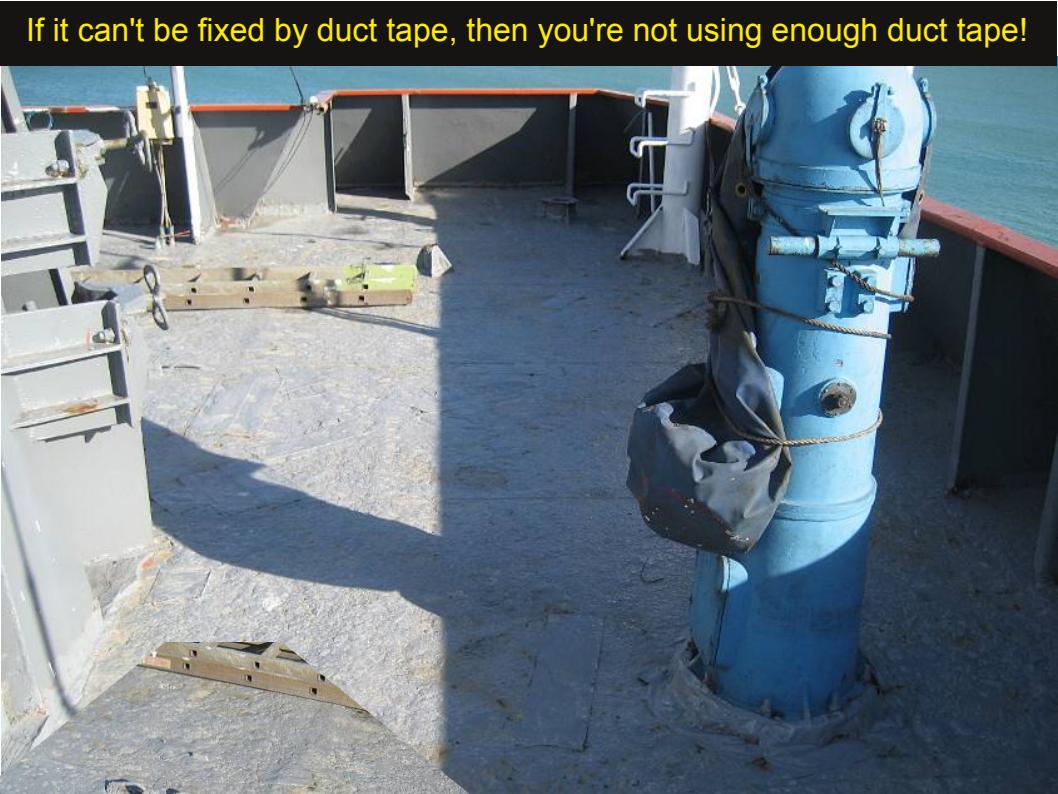
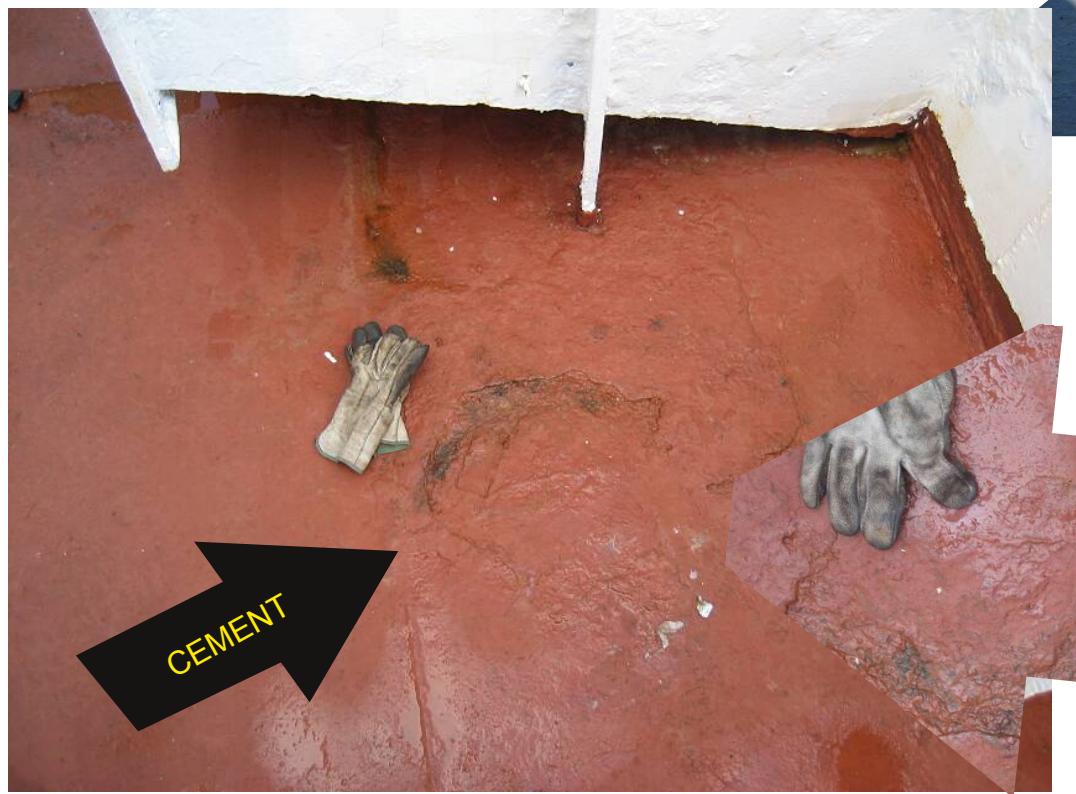
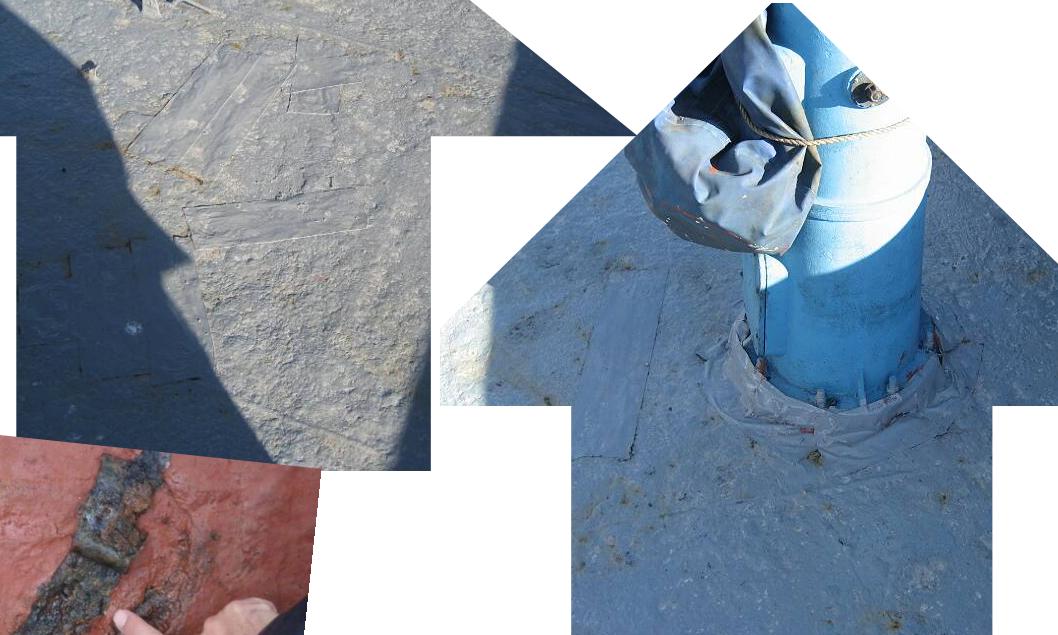
Plaster, duct tape, cement, silicone and inches of paint to cover them

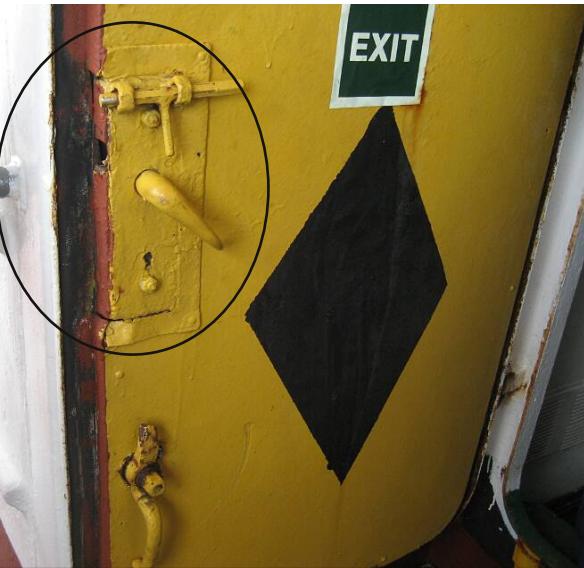
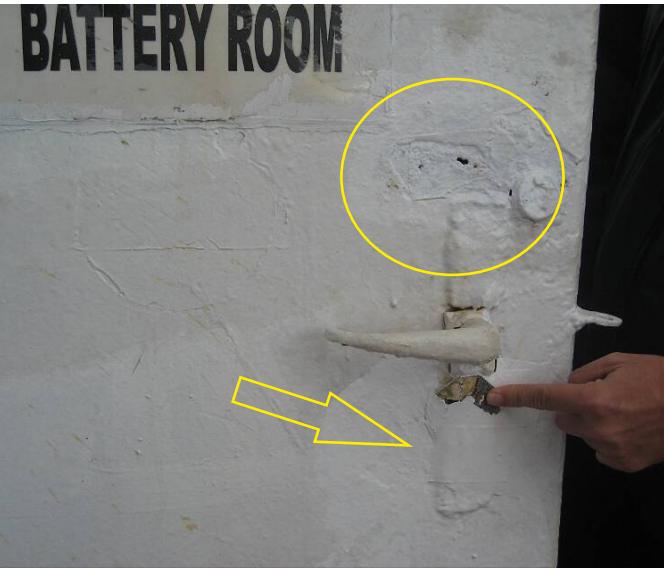
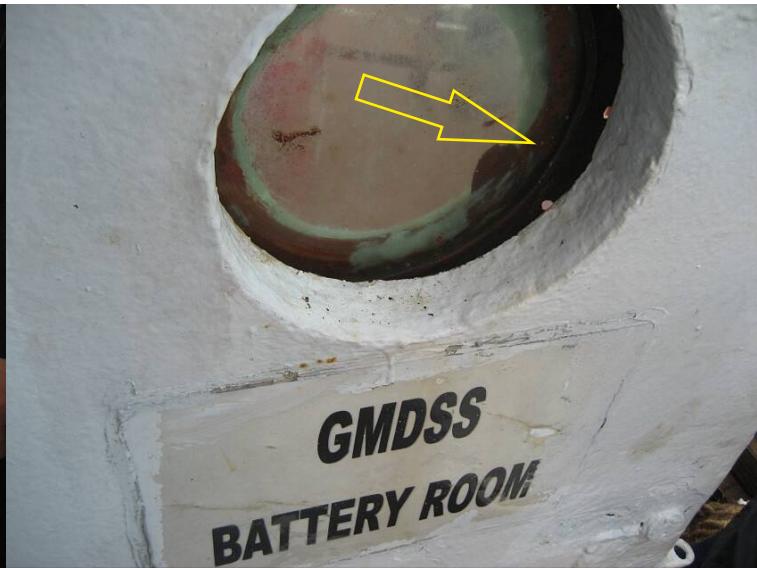
LOAD LINE AND FIRE DOORS

- 1) all doors (both fire doors and watertight doors) were corroded thorough, damaged, deformed, without closing systems (handles, locks, self closing devices where needed), holed or temporary repaired by duct tape or silicone;

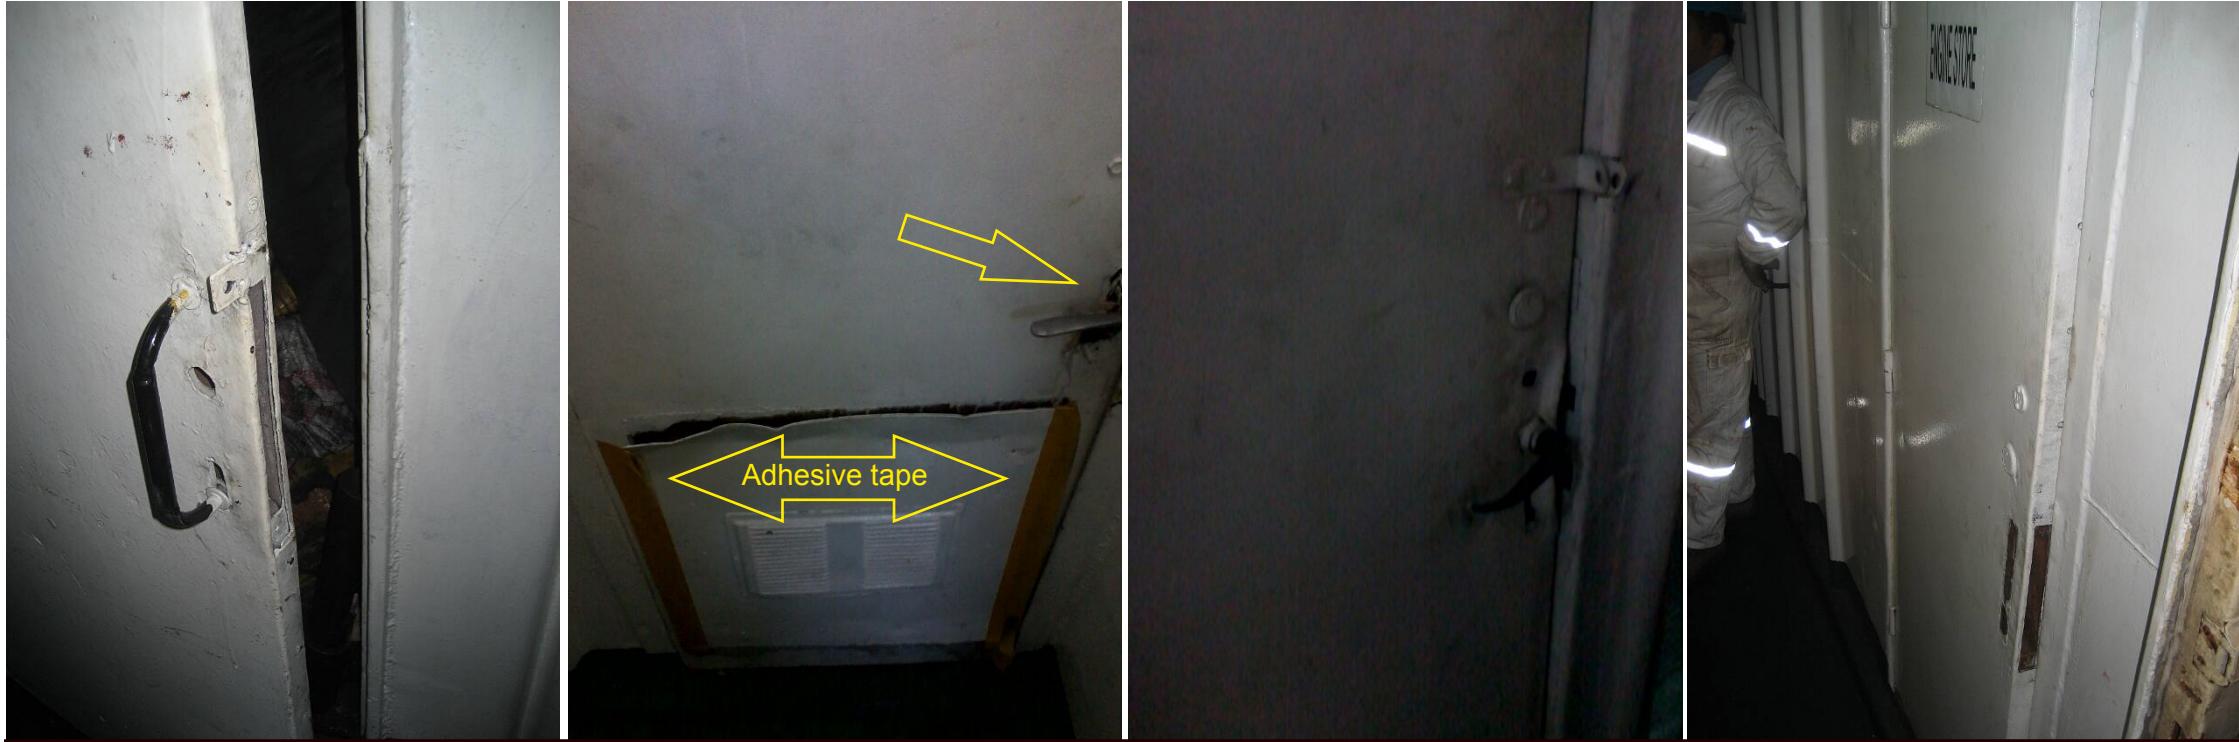
FIRE DOORS, DIVISIONS AND PENETRATION

- 16) several bulkhead divisions (most of them A class division) removed or shifted or holed;
- 17) SART and BNWAS were out of order;
- 18) several fire doors were removed;

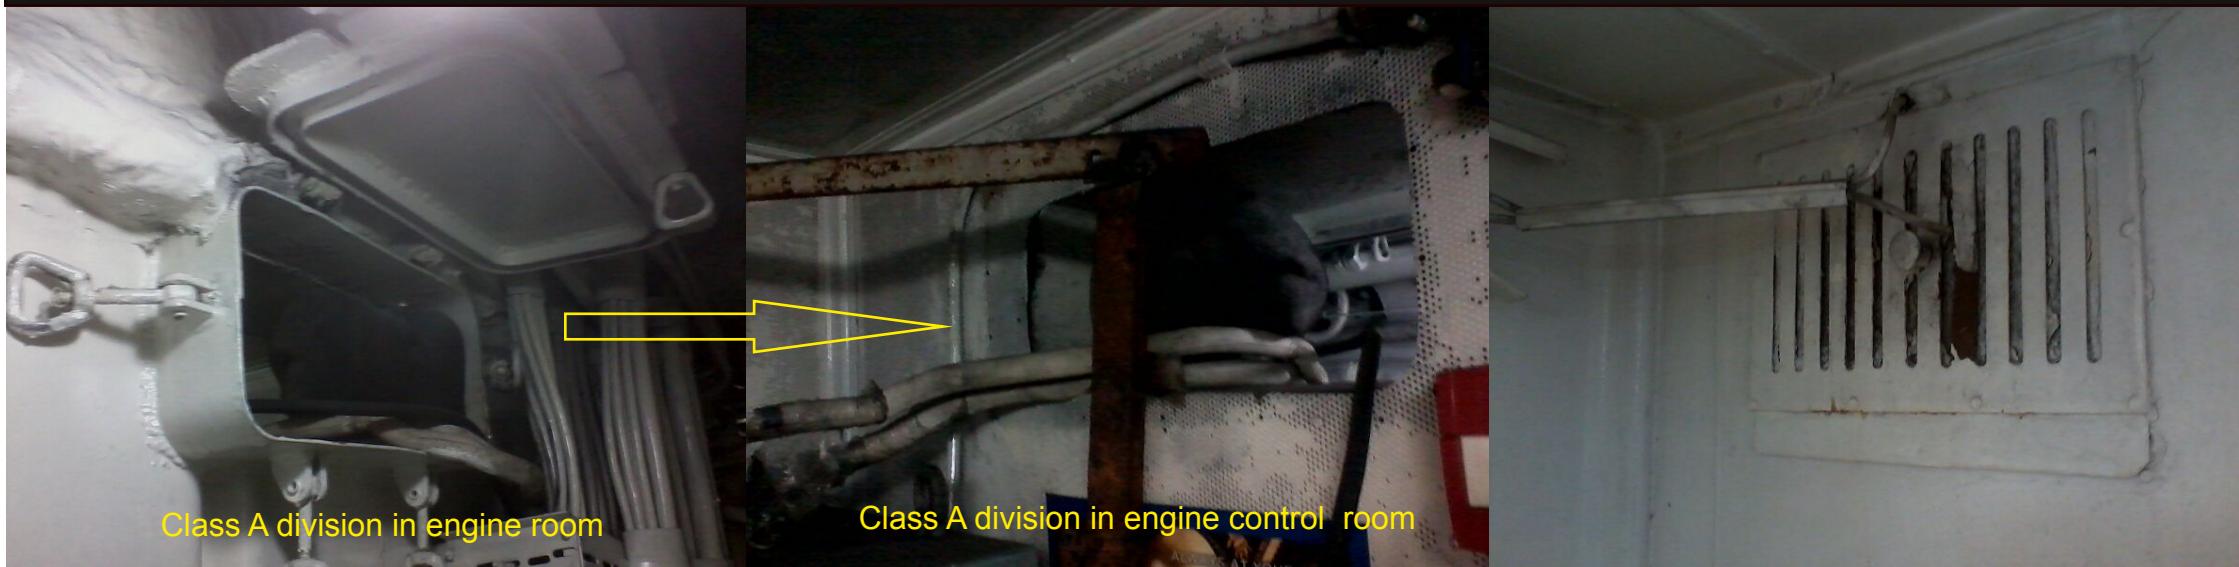
Class A division in engine room

Class A division in engine control room

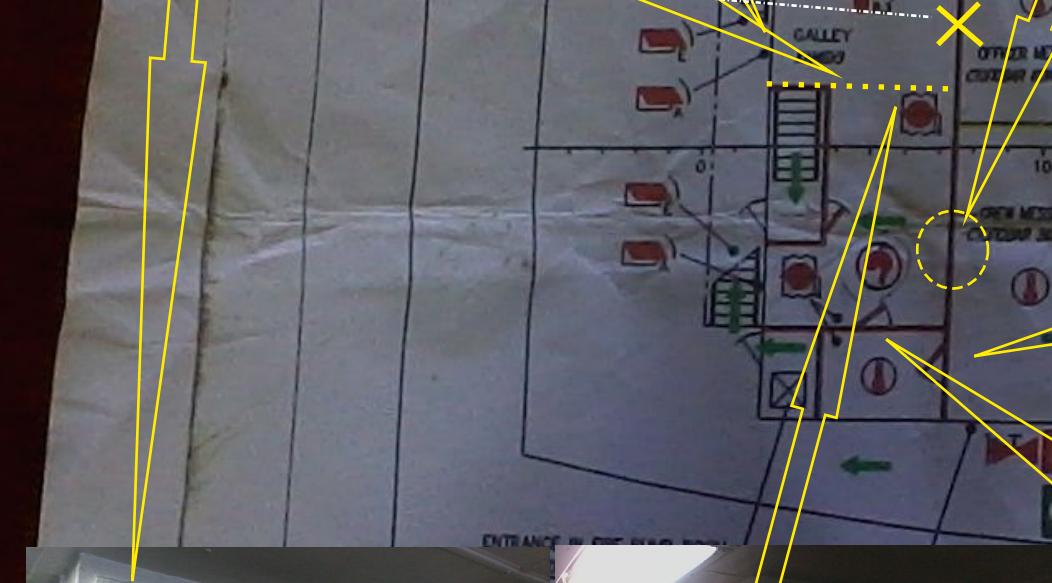
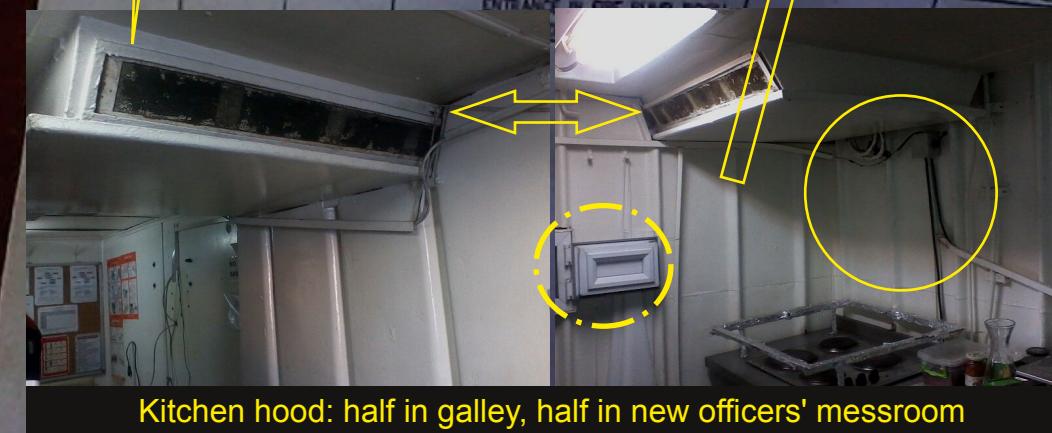
Kitchen hood: half in galley, half in new officers' messroom

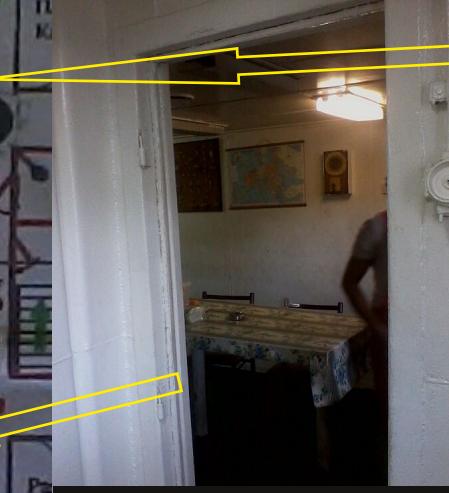
Fire doors missing (removed)

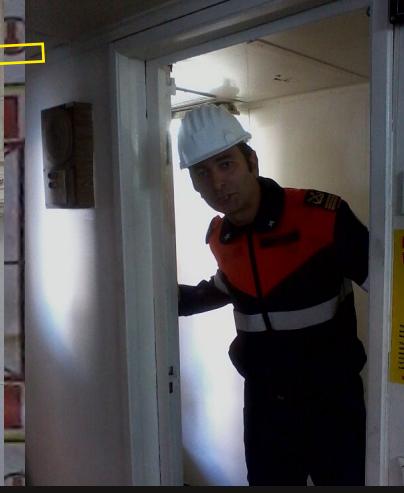
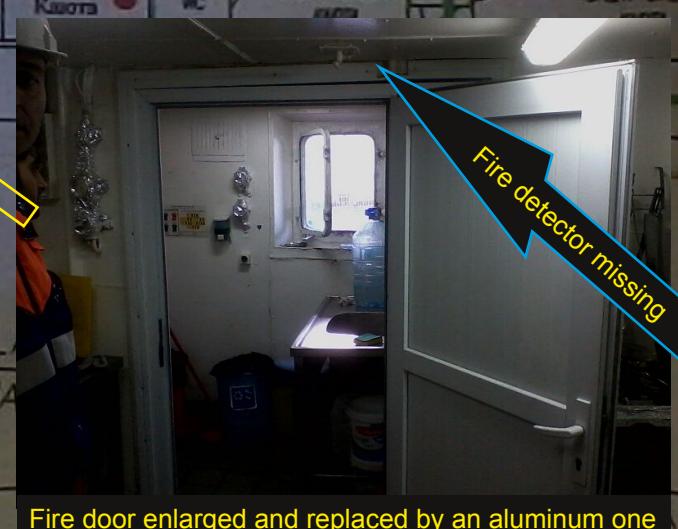
Fire door enlarged and replaced by an aluminum one
Fire detector missing

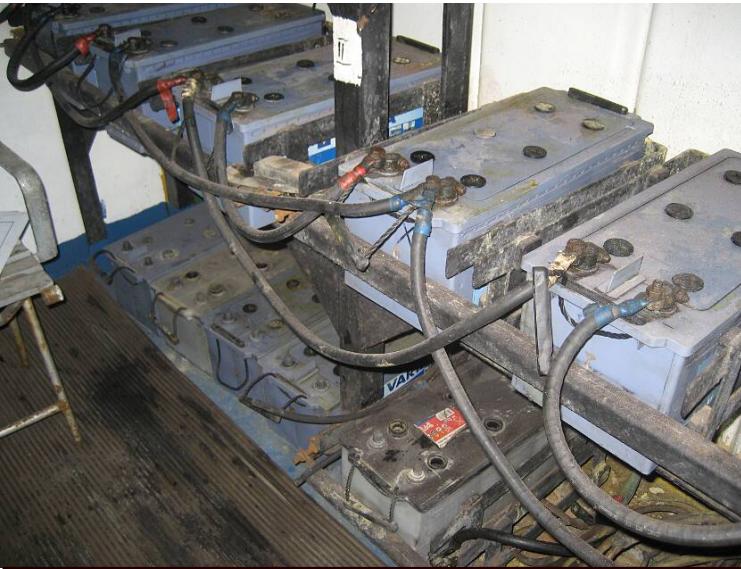
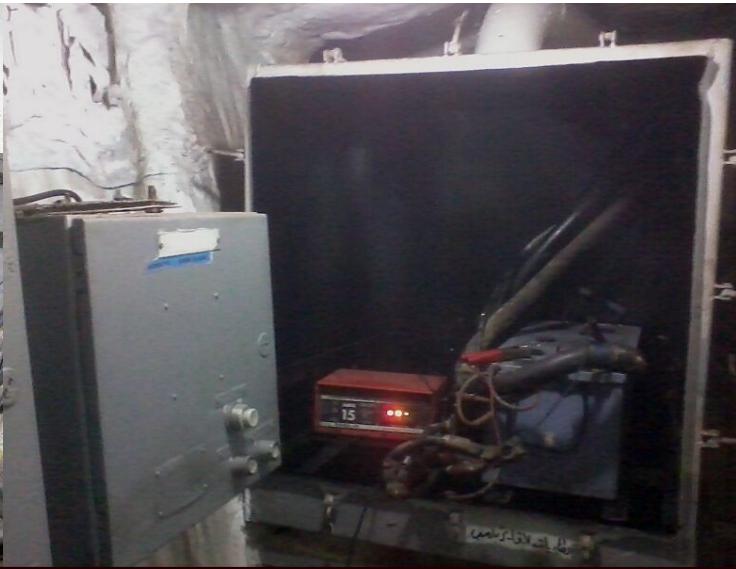
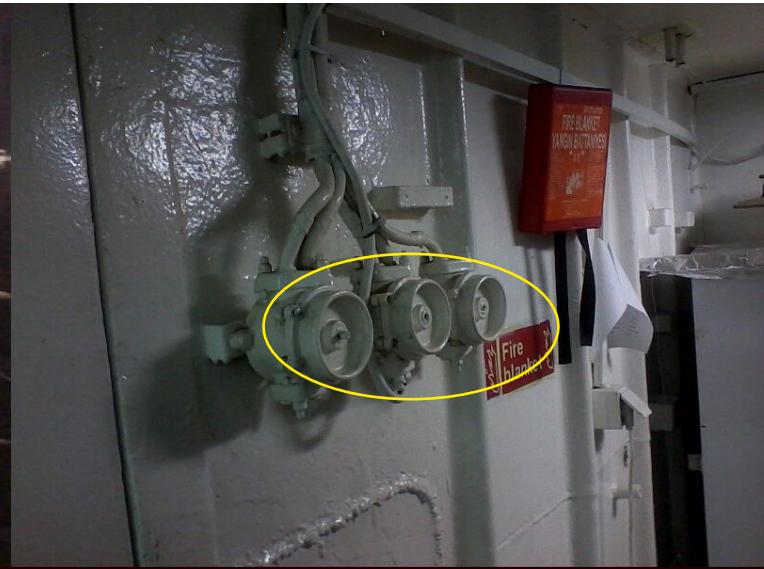
ELECTRICAL

- 15) several electrical deficiencies noted: some apparatus was disconnected from earth line; several light covers were missing; several wires were improperly fixed and not protected, several light switch were broken;

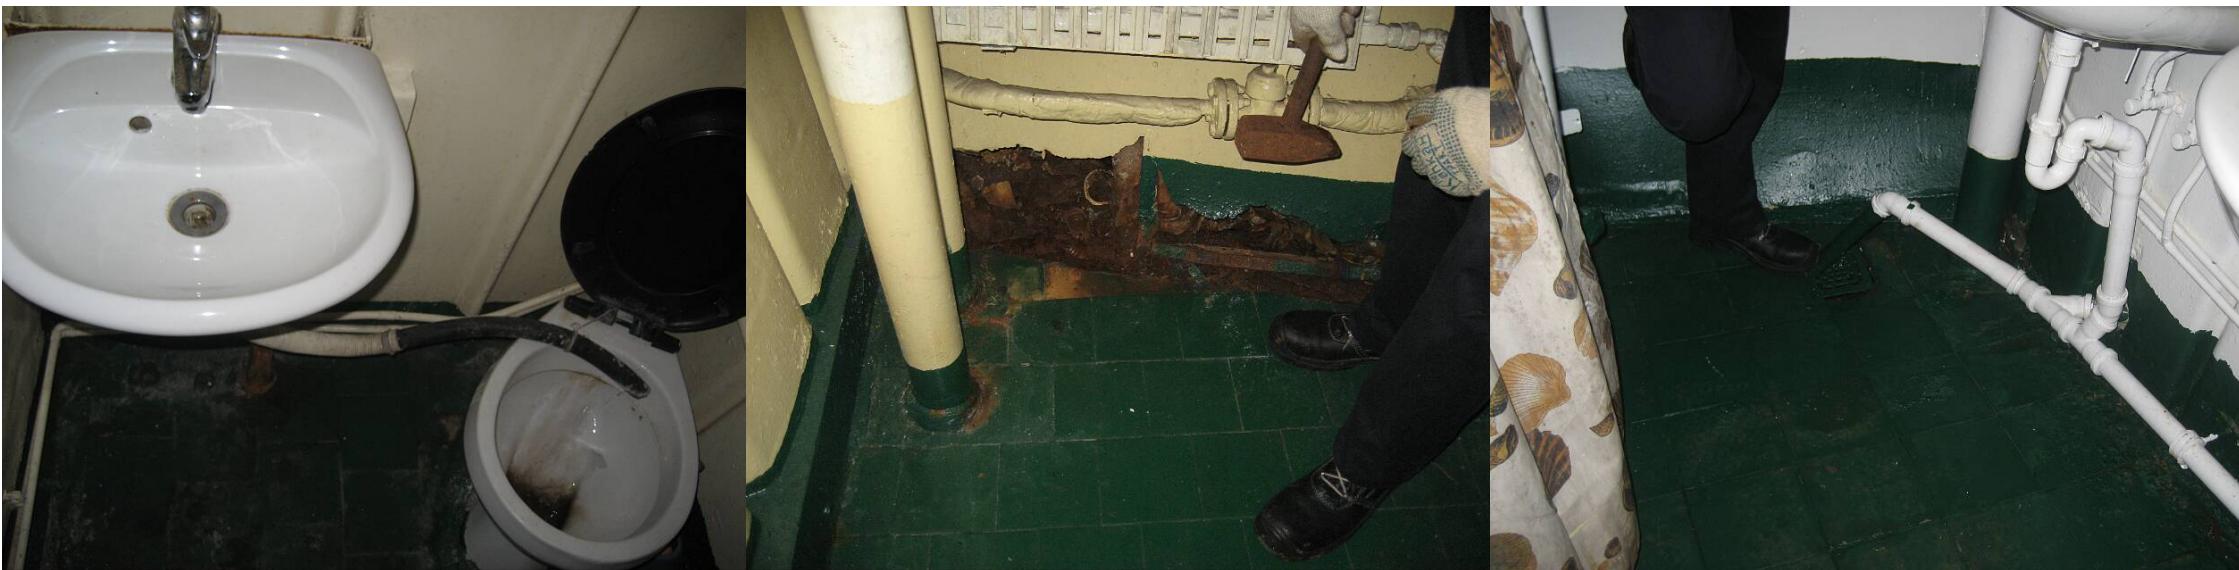
FOOD QUANTITY AND STORE AND HYGIENIC CONDITIONS

- services, lights and navigational equipment - was out of charge;
- 21) several windows were heavily corroded and not weathertight (often temporary repaired by foam or cement or blinded by welded iron plates);
- 22) all cold rooms were inoperative;
- 23) food was insufficient and improperly stowed and segregated;
- 24) garbage was not handled according to Marpol provisions; a big quantity of garbage was found onboard;
- 25) drainage system in galley and accomodation area was obstructed;
- 26) draining systems for lavatories, washbasin and showers were damaged or removed;
- 27) embarkation ladders were worn out and broken;
