## “Craig Trans”/IMO#8424551

The Bolivian-flag tug “Craig Trans” arrived at Halifax, Nova Scotia on 2012-12-18, with engine and generator problems, during a voyage from the Panama Canal to Montreal, Canada. When “Craig Trans” arrived, the Pilot noticed that the Port anchor was missing. As the Master wanted to anchor in Halifax harbour, the Pilot asked how much chain was on the Starboard anchor. The Master informed him that there was 40 metres of chain, which the Pilot believed was not enough for the depth in the anchorage, as the weather forecast was for 50 Knots wind that night. The Pilot arranged for a berth at Pier 26. The crew of “Craig Trans” then went to the Mission to Seafarers and asked for food, as they had not eaten for three days. The Mission gave them food.

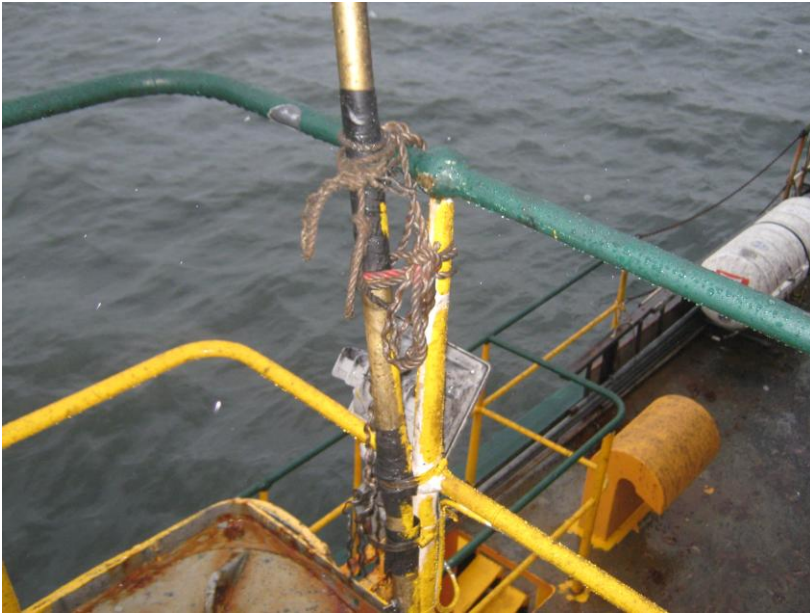
The “walk-about” revealed that the top of the wheelhouse was patched with cement to prevent water leaking through the holes onto the navigational equipment. The MF radio aerial was held onto the rail by rope.
