SUAT BEY

IMO9070515

Type: General cargo

[MV Suat Bey](#) arrived in Catania (Italy) on 09nov2013, with a standard risk profile.

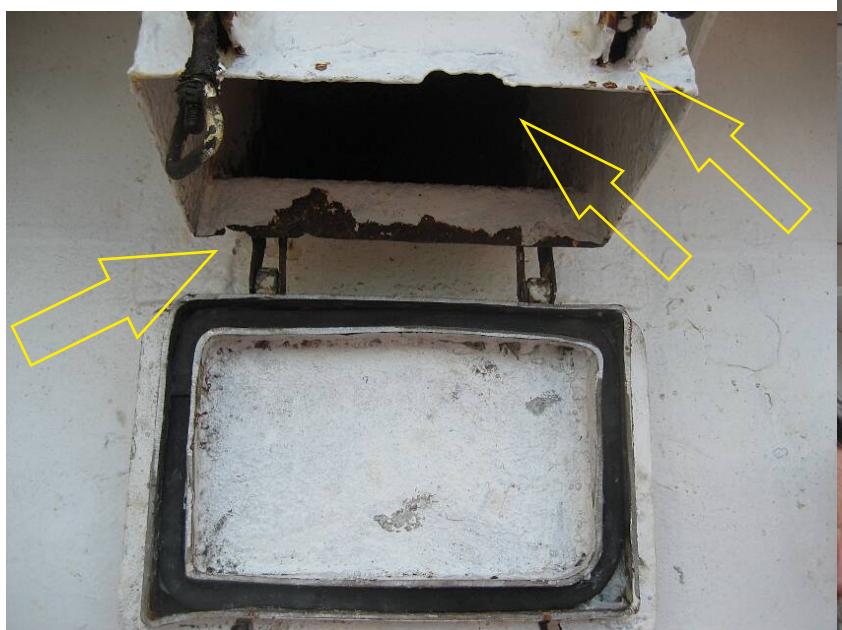
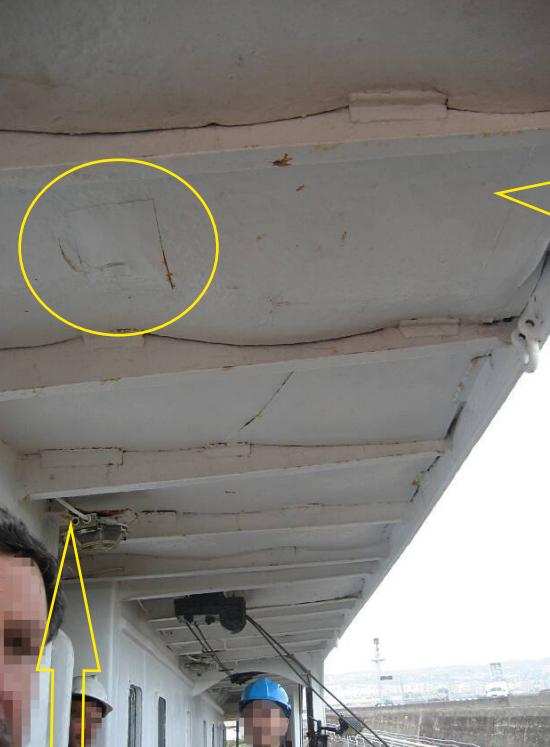
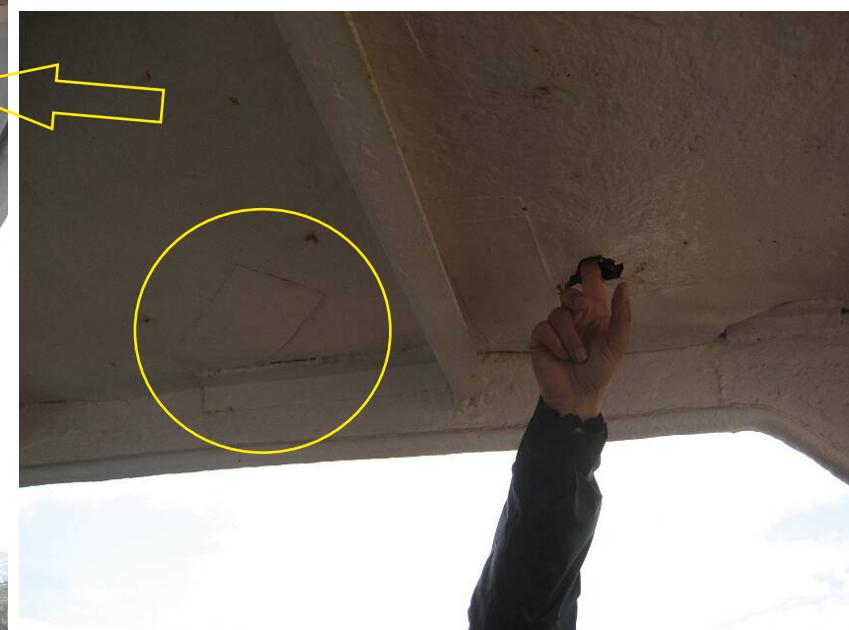
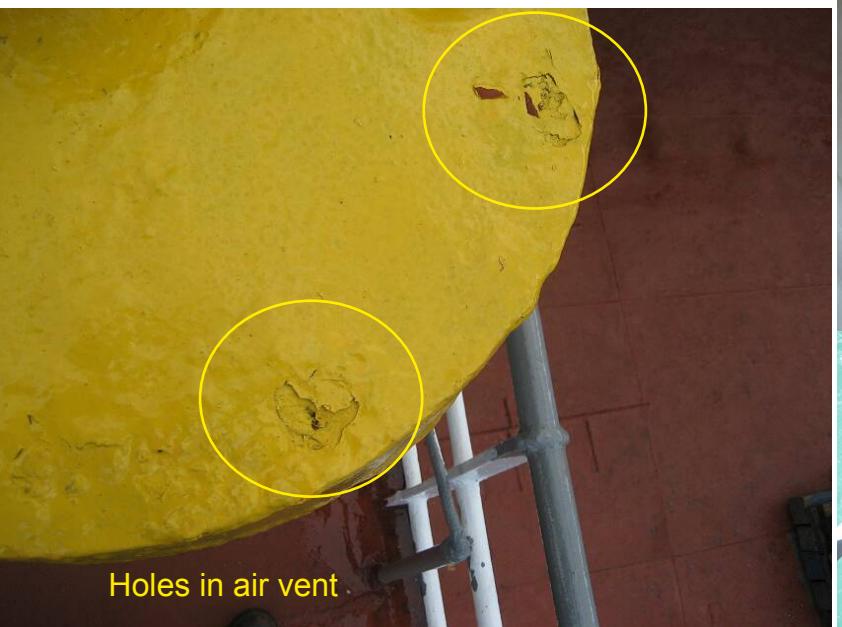
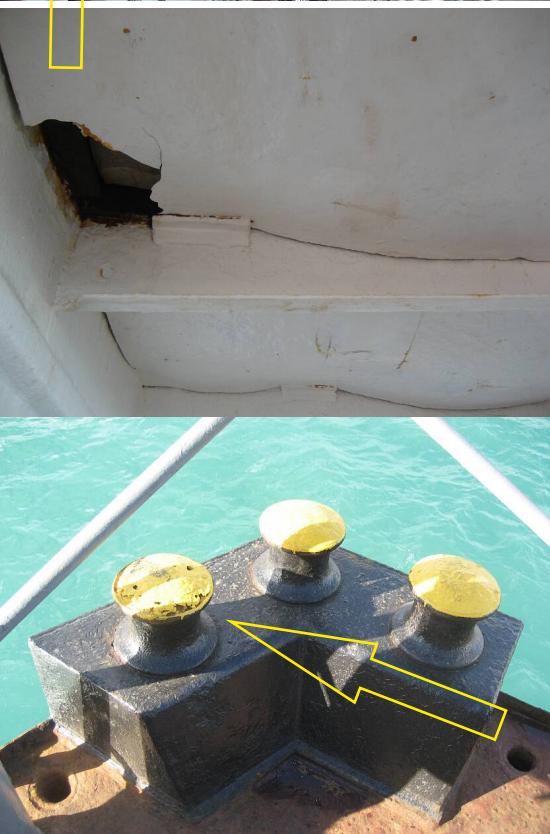
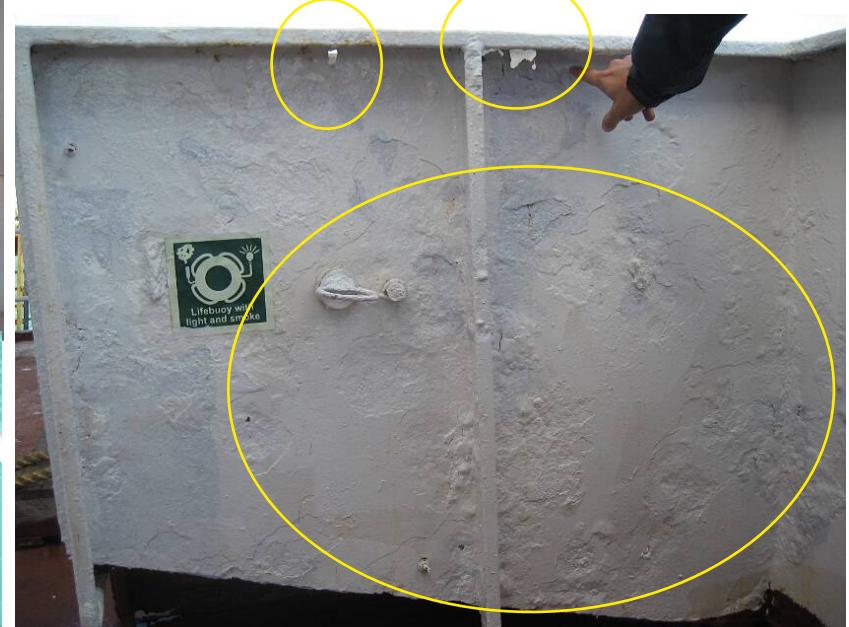
Plaster, duct tape, cement, silicone and inches of paint to cover them

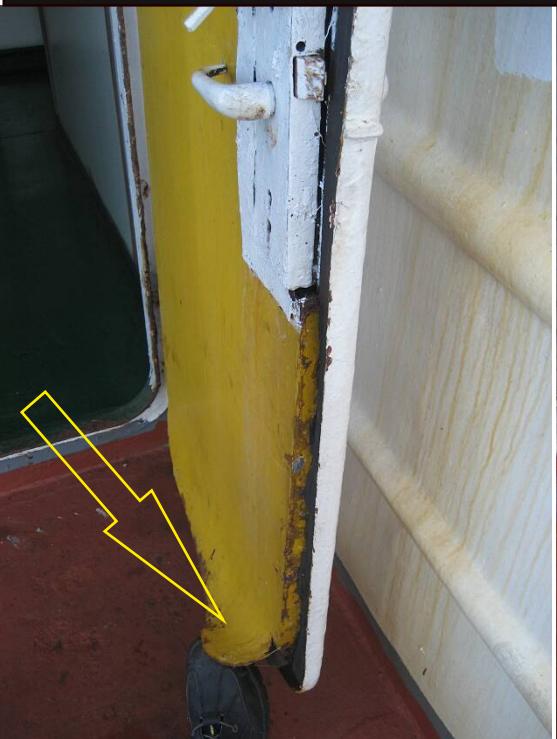
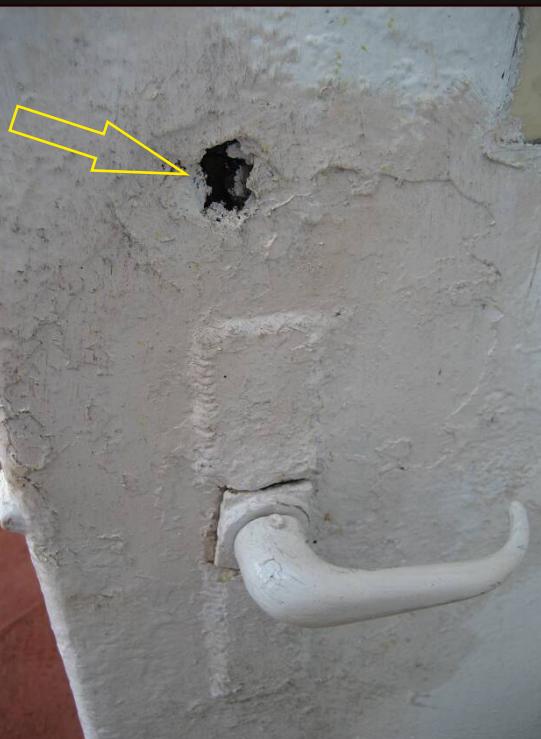
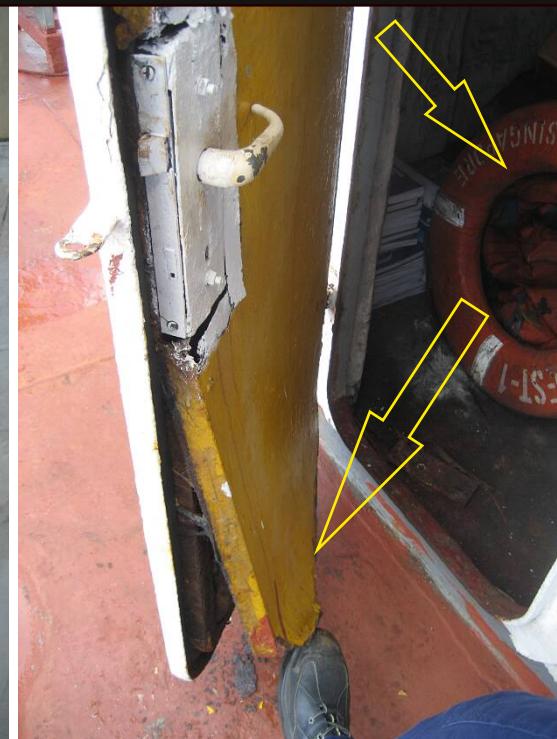
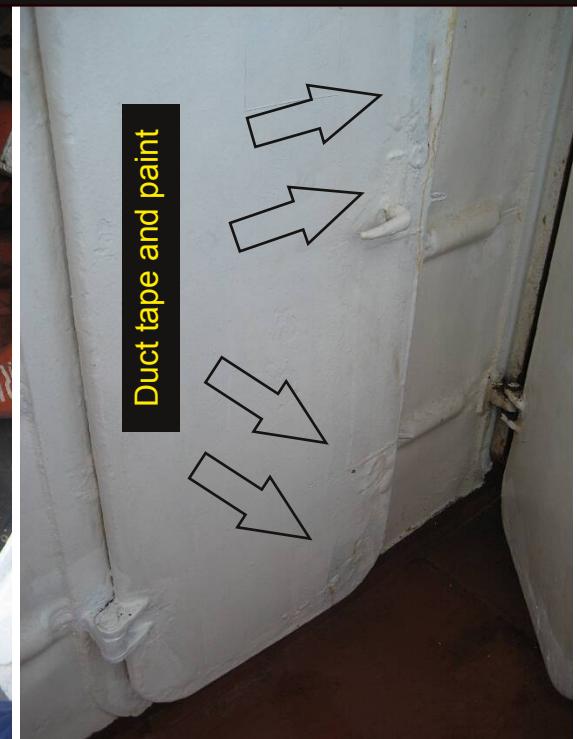
LOAD LINE AND FIRE DOORS

- 1) all doors (both fire doors and watertight doors) were corroded thorough, damaged, deformed, without closing systems (handles, locks, self closing devices where needed), holed or temporary repaired by duct tape or silicone;

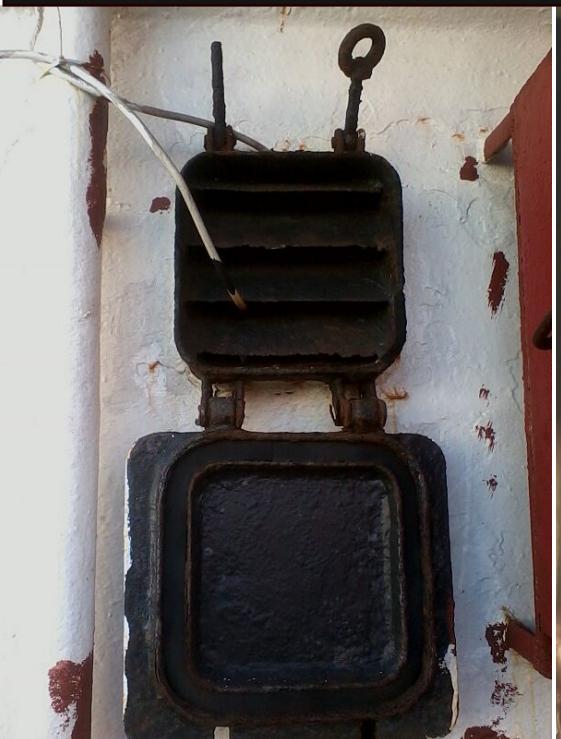
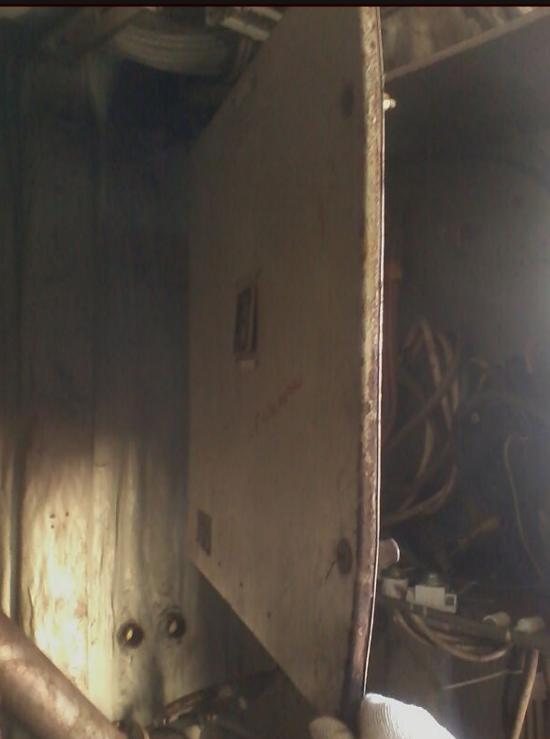
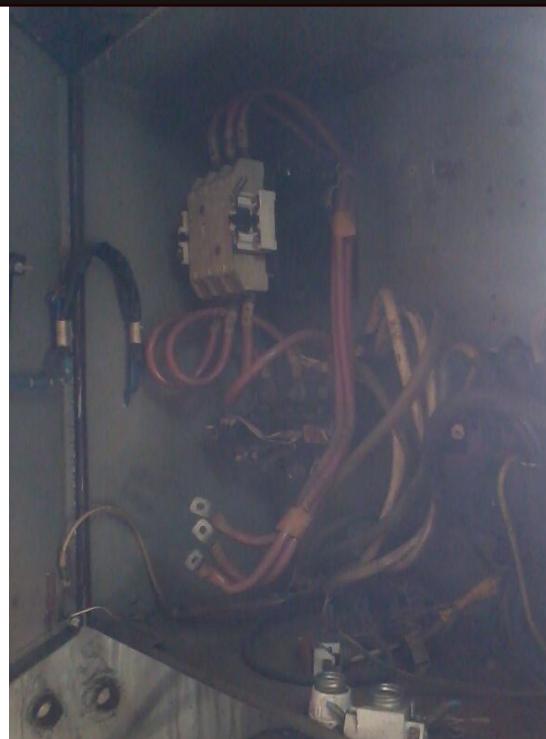
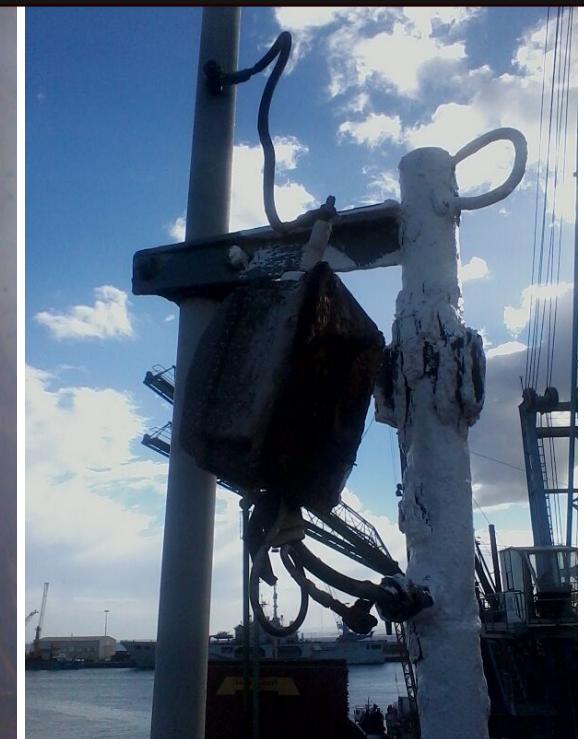
ELECTRICAL

- 15) several electrical deficiencies noted: some apparatus was disconnected from earth line; several light covers were missing; several wires were improperly fixed and not protected, several light switch were broken;

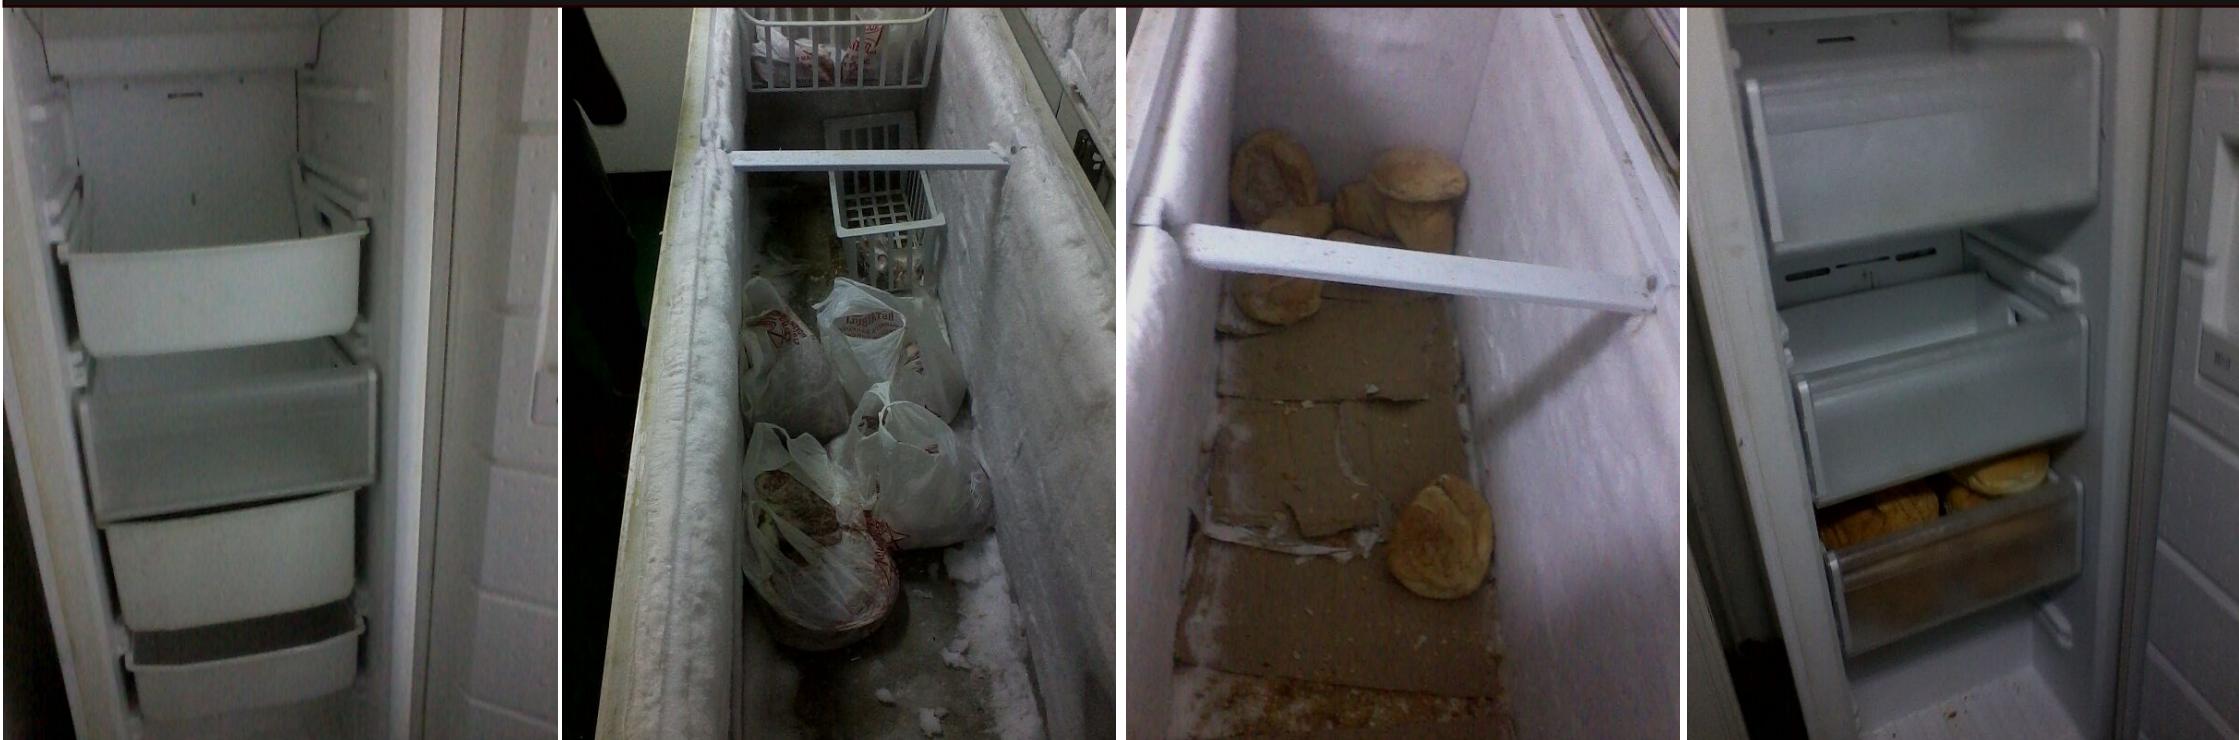
FOOD QUANTITY AND STORE AND HYGIENIC CONDITIONS

- services, lights and navigational equipment - was out of charge;
- 21) several windows were heavily corroded and not weathertight (often temporary repaired by foam or cement or blinded by welded iron plates);
- 22) all cold rooms were inoperative;
- 23) food was insufficient and improperly stowed and segregated;
- 24) garbage was not handled according to Marpol provisions; a big quantity of garbage was found onboard;
- 25) drainage system in galley and accomodation area was obstructed;
- 26) draining systems for lavatories, washbasin and showers were damaged or removed;
- 27) embarkation ladders were worn out and broken;
